## CASE STUDY

# Successful leak detection in the Middle East with multifinger caliper and Archer VIVID™

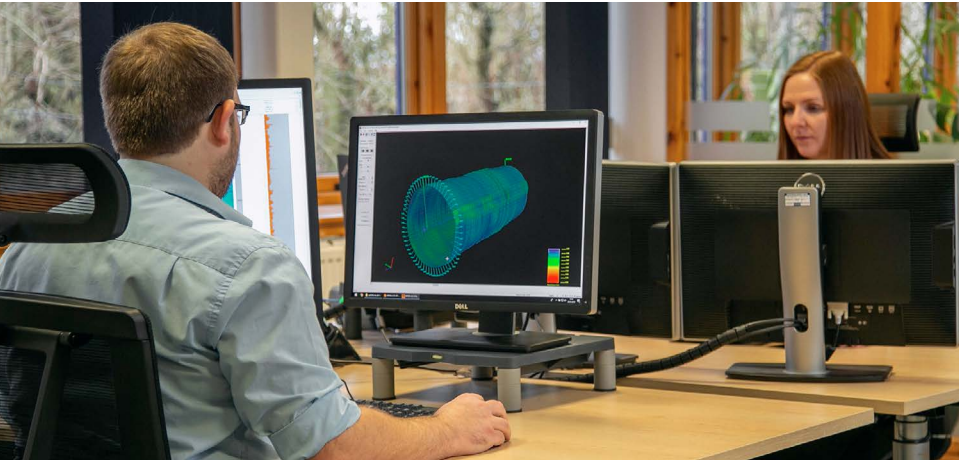
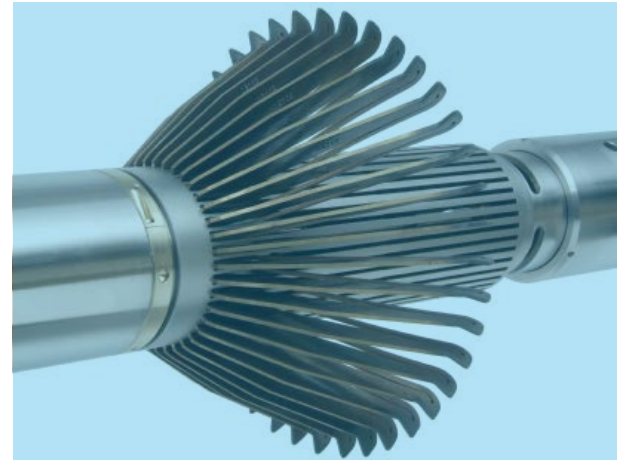
Barrier leak as identified by READ's 40-finger caliper and Archer's VIVID™ acoustic listening platform.

The Archer VIVID™ acoustic listening platform revealed the source of the leak channel, which was corroborated by conventional centerline sensors. The acoustic data indicated a leak path from the tubing to the A-annulus at the Side Pocket Mandrel (SPM).

The leak was identified by an acoustic energy signature recorded while injecting to tubing and bleeding off the A-annulus to create sufficient differential pressure to activate the leak.

Elevated levels of acoustic energy detected above the leak could be attributed to gas flow from the leak in the A-annulus.

The answers delivered by our ANSA data analysis team demonstrated that the tubing was in good condition with no indication of significant metal loss or deposition throughout.
