## CASE STUDY

# 20" casing integrity evaluation using 80-arm multifinger caliper (MFC80)

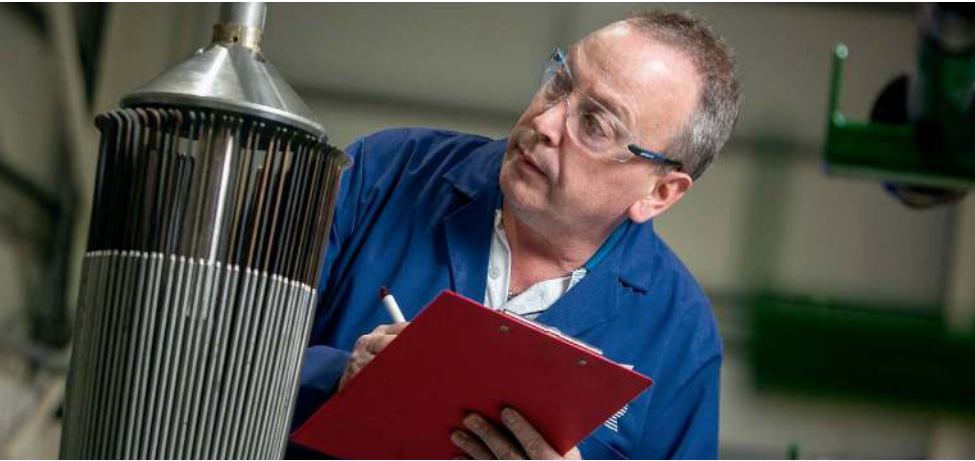
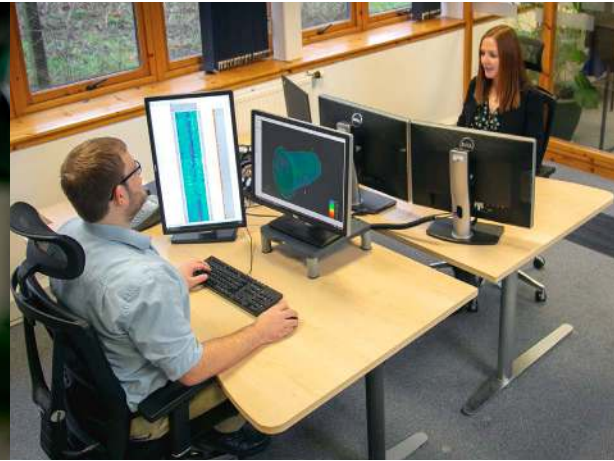
READ's data analysis report indicating damage features with 77% and 100% penetration.

The comprehensive report delivered by our ANSA team showed that the casing had multiple zones with metal loss, with several showing full wall penetration. Deposition was also found at varying degrees.
